Rocking of a bell tower - investigation by non-contact video measurement

Paul F. McCombie, Department of Architecture and Civil Engineering, University of Bath, U.K.

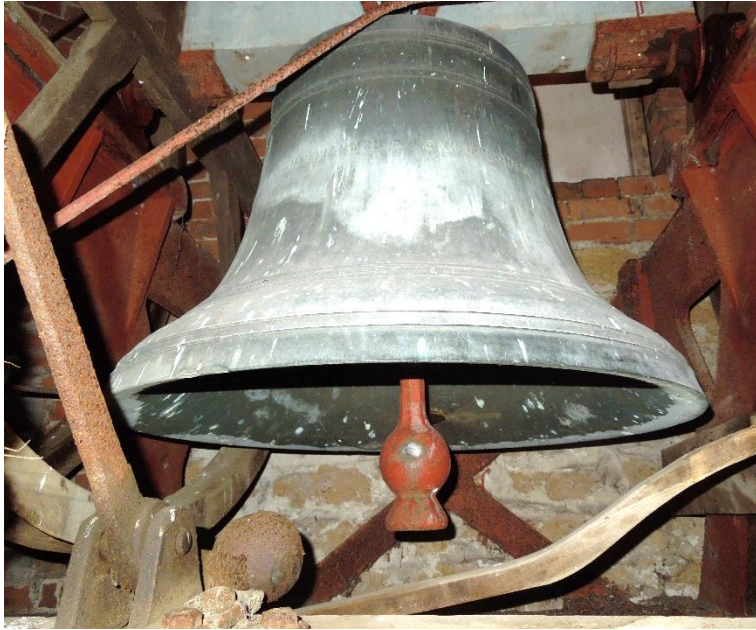
Figure 1 A church bell mounted for full-circle ringing. The wheel is on the left, to which is attached the headstock, to which the bell is attached. The shaft, ball and flight of the clapper are clearly seen inside the bell. A rope runs around the wheel rim to make the bell swing and control its movement.

As the bell swings, the clapper swings inside it; the clapper incorporates a flight, an extension of the shaft beyond the ball that strikes the bell (Figure 1), so that it behaves as a longer pendulum than the bell and so swings more slowly, catching up with the bell and striking it as the bell slows down approaching the top of its swing. This arrangement gives the ringers fine control of the timing. It is possible to produce a single stroke of the bell, but ringing is usually continuous. The speed can be adjusted, because a little resistance applied to the rope as the bell approaches the top of its swing will slow it down, allowing the clapper to catch up with it earlier. Conversely, if the rope is pulled a little harder, or less resistance applied as it swings towards the top, then the bell will swing closer to the top, and the clapper will take longer to catch up and strike it. In normal ringing the bells are not swung through the full 360°, so that they can be easily slowed down or sped up for a single strike, to change their place in the sequence of bells. "Rounds" is ringing the highest pitched bell (the treble) first, then each bell in sequence through to the lowest pitched (the tenor), with even time intervals between each strike. Then by using the techniques described to produce small changes in the timing, two bells can be made to swap their positions in the sequence. This enables what is known as "change ringing", in which the sequences are changed according to calls or repeated predefined patterns known as "methods" or "principles"; this is the classic sound of British church bells.

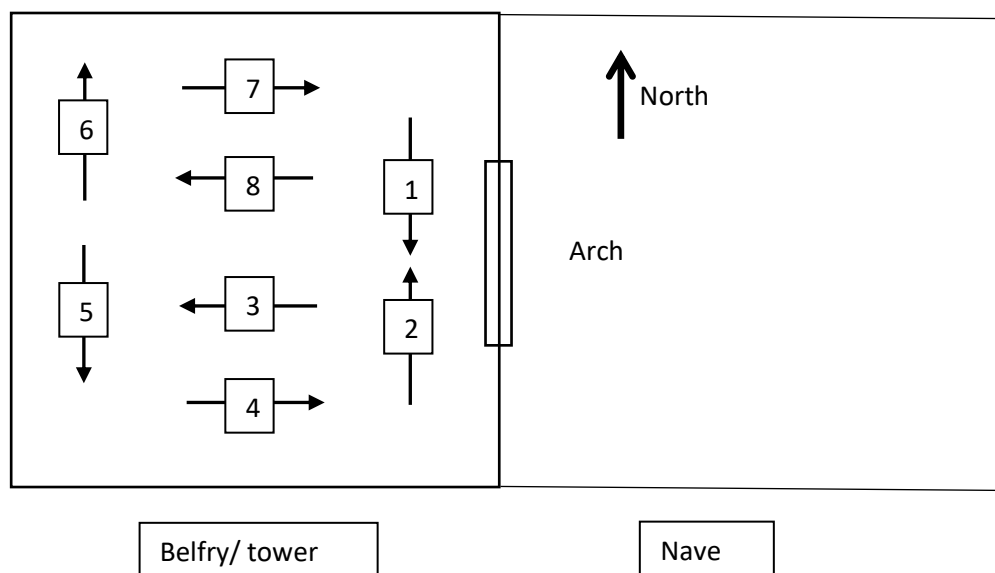
Figure 3 Schematic diagram showing the positions of the bells in the belfry, and the direction of first movement at the start of normal ringing

sequences, which change, so this apparent attempt to reduce the imbalance of forces is not always effective. The heaviest bells, numbers 7 and 8, are orientated to ring on the E-W axis, in the expectation that the presence of the nave, the main body of the church, will stiffen the tower's response in that direction. Photographs of the outside and inside of the church, and of the bells, are given in Figure 4. The high and wide archway between the tower and the nave, seen in Figure 4b, introduces a weakness in the E-W direction, resulting in cracking at the top of the arch (Figure 4d). The width of the crack was observed in this study to change in correspondence with the forces imposed by the ringing of the bells.

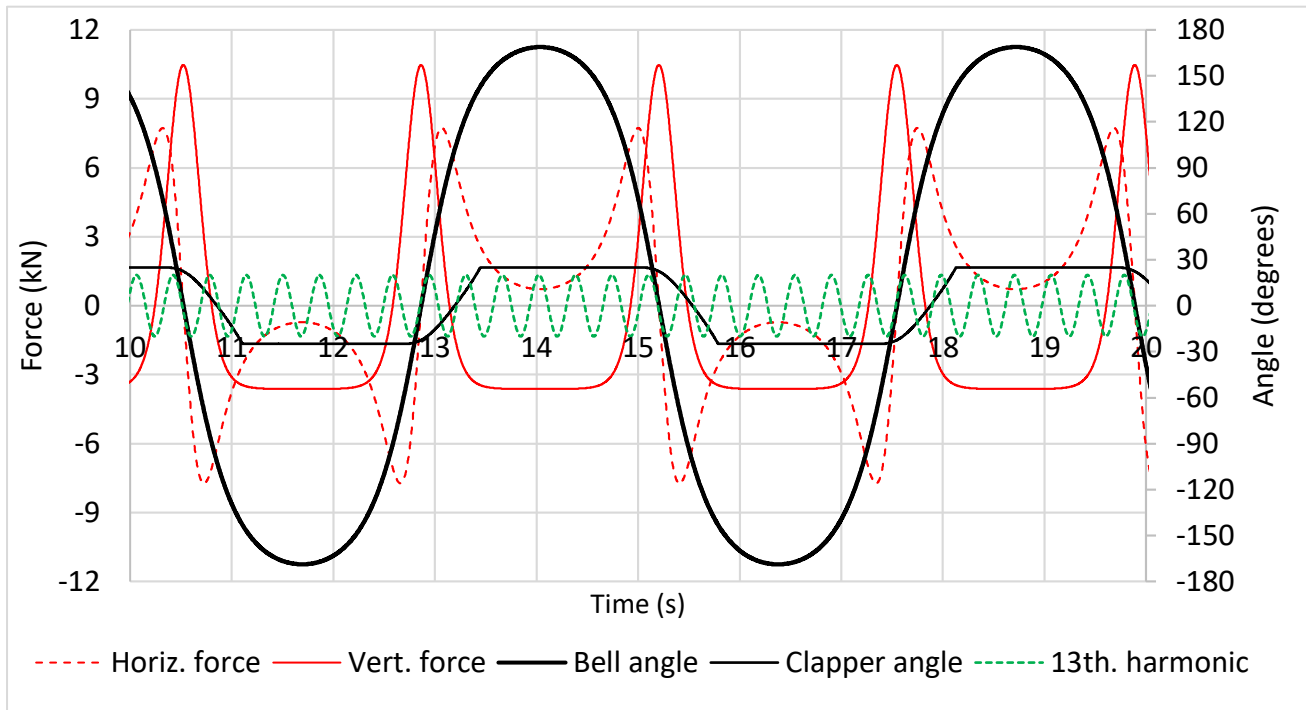
Figure 5. Simulation of bell motion and forces.

Figure 5 shows the bell swung up to 169° , (0° is the ‘down’ position, 180° is ‘up’); the interval between strikes corresponds approximately to that rung during the tests reported below, and during normal ringing. The thirteenth harmonic has a frequency of about that observed for the flexing of the tower, about 3.5Hz. There is some correspondence between the horizontal impulse and the natural frequency, in that each pulse corresponds to two peaks in the same direction but only one in the opposite direction. The forcing of the tower by this pattern is nevertheless weak. It can be seen that even a very small variation of the timing of the ringing will mean that the successive peak horizontal forces acting in opposite directions could switch from reinforcing the movement to counteracting it. Therefore no matter what might be said about the mathematical correspondence between an n^{th} harmonic of the bell swing and the resonant frequency of the tower, the actual movement of the bell, controlled by a ringer, with an open handstroke and changes of place, is very unlikely to continuously reinforce the flexing of a tower with such a high natural frequency. Typically towers are considered to have a fundamental frequency for flexing of about $46/H$ (for example [13]), where H is the height in metres and the frequency is in Hz; this yields 2.88 Hz for the 16m high tower at Longbridge Deverill. St Mary Magdalene in Taunton, Somerset, has a very tall tower of 50m (including the decorative pinnacles) which undergoes significant movement, and would be expected to have a natural frequency of about 0.92 Hz. Figure 7 shows the horizontal force from Figure 5 together with a harmonic at a frequency for a tower of about 44m (1.05Hz, approximately corresponding to the tower below the decoration). It can be seen that the simple harmonic curve corresponds with the more complex curve of the force from the bell in such a way that the tower will resonate: the peaks and troughs of horizontal force align with the peaks and troughs of the tower’s resonance. See, for example, where the markers (a) and (b) have been placed in Figure 7 at about 15.1s and 15.6s.

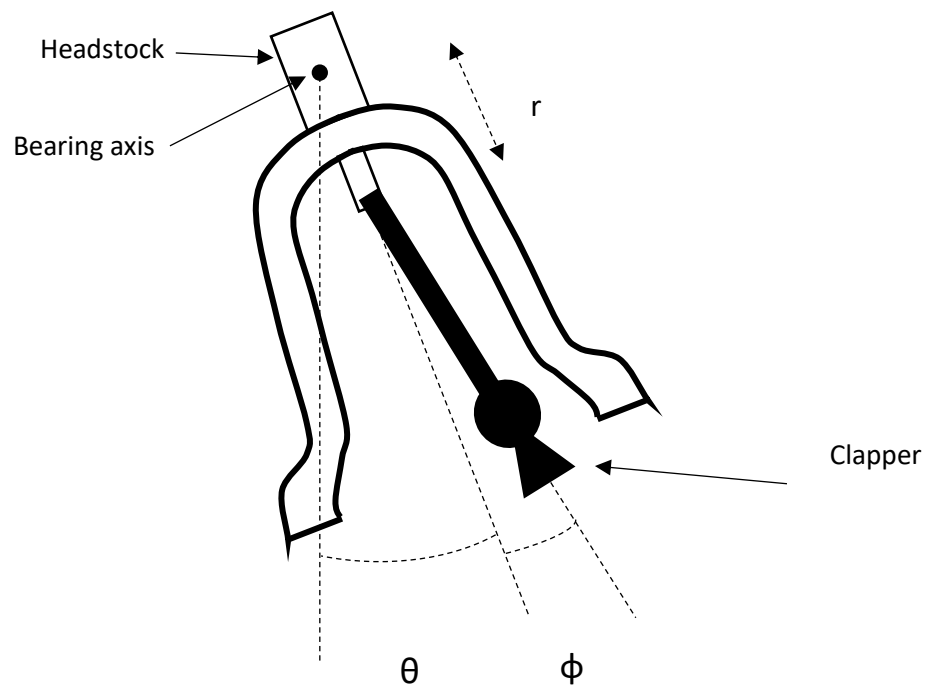
Figure 6 Schematic section through bell showing notation for equations

In these equations, the bell and its wheel and headstock, with total mass M , have moment of inertia I_b about its bearing, and its centre of mass is distance a from its axis. Corresponding values for the clapper are m , I_c and b , while the axis of rotation of the clapper lies within the bell, a distance r below the axis of the bell. The angle between the bell and the downwards vertical is θ , and that between the clapper and the bell's axis is ϕ (Figure 6). Q_θ and Q_ϕ are then 'generalised forces', the most important being that applied by the ringer via the rope – and hence not a continuous function.

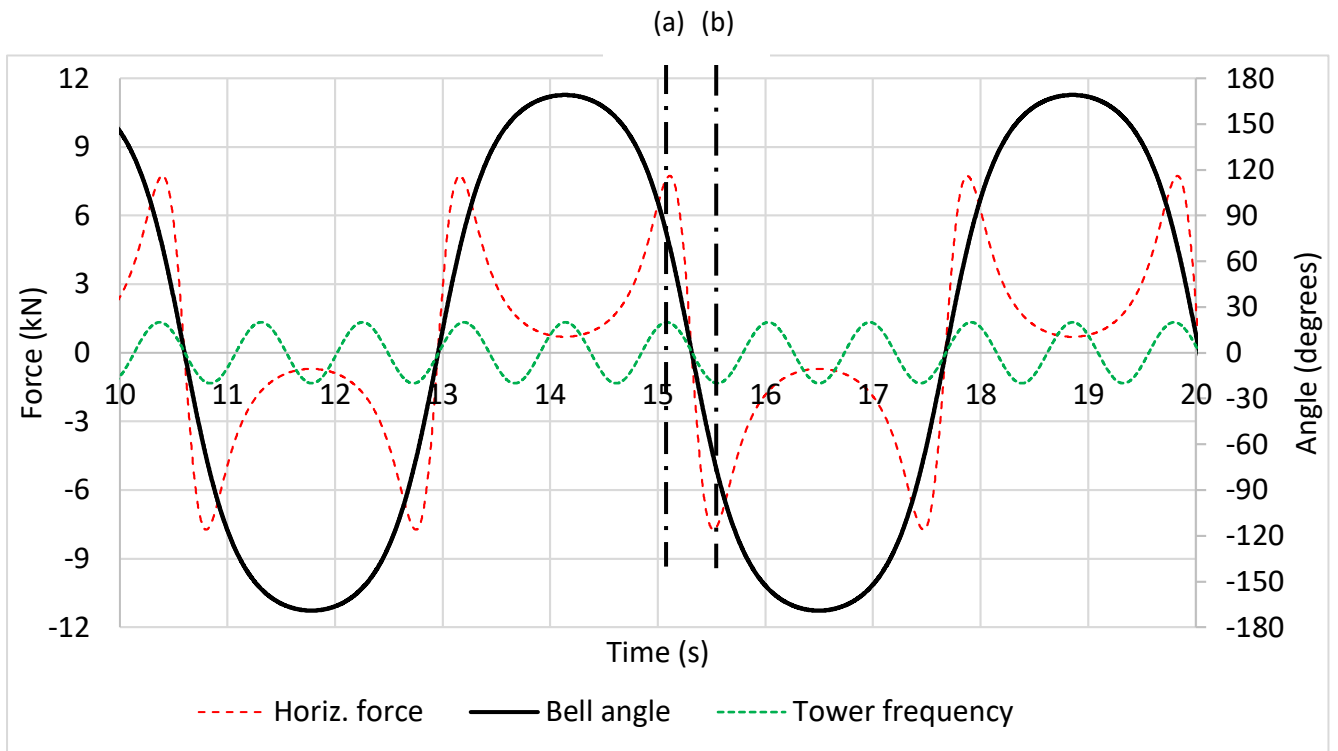
Figure 7. Relationship between horizontal bell force and the natural frequency of a tall tower

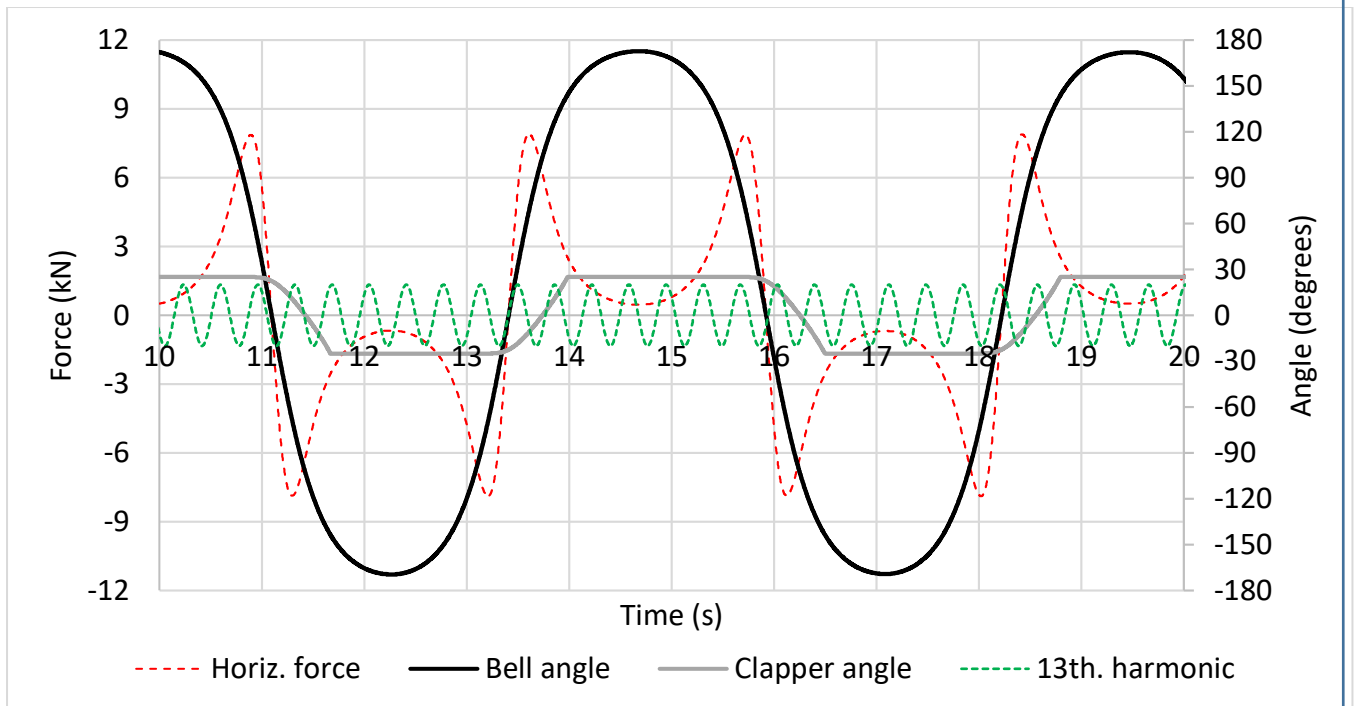
Figure 8. The effect of an open handstroke

The forces applied to the bell by the ringer have been adjusted to produce a typical ringing speed and the open handstroke. The dotted line is the thirteenth harmonic of the overall ringing speed, and is close to the natural frequency of the Longbridge tower.

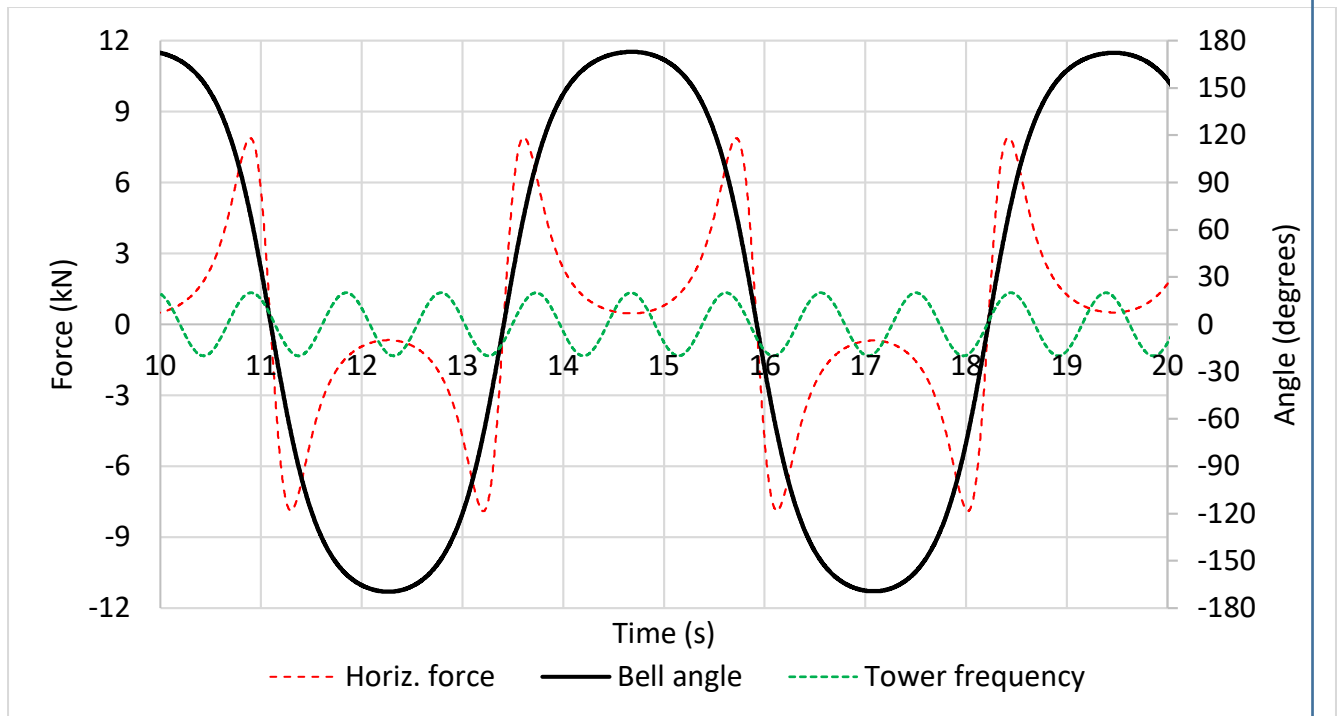
Figure 9. The effect of an open handstroke in a tall tower

This shows the equivalent of figure 7, but ringing with an open handstroke. Though the alignment between the horizontal force pattern and the tower frequency varies a little over time, it is still close enough that the force from the bell will produce a resonant response.

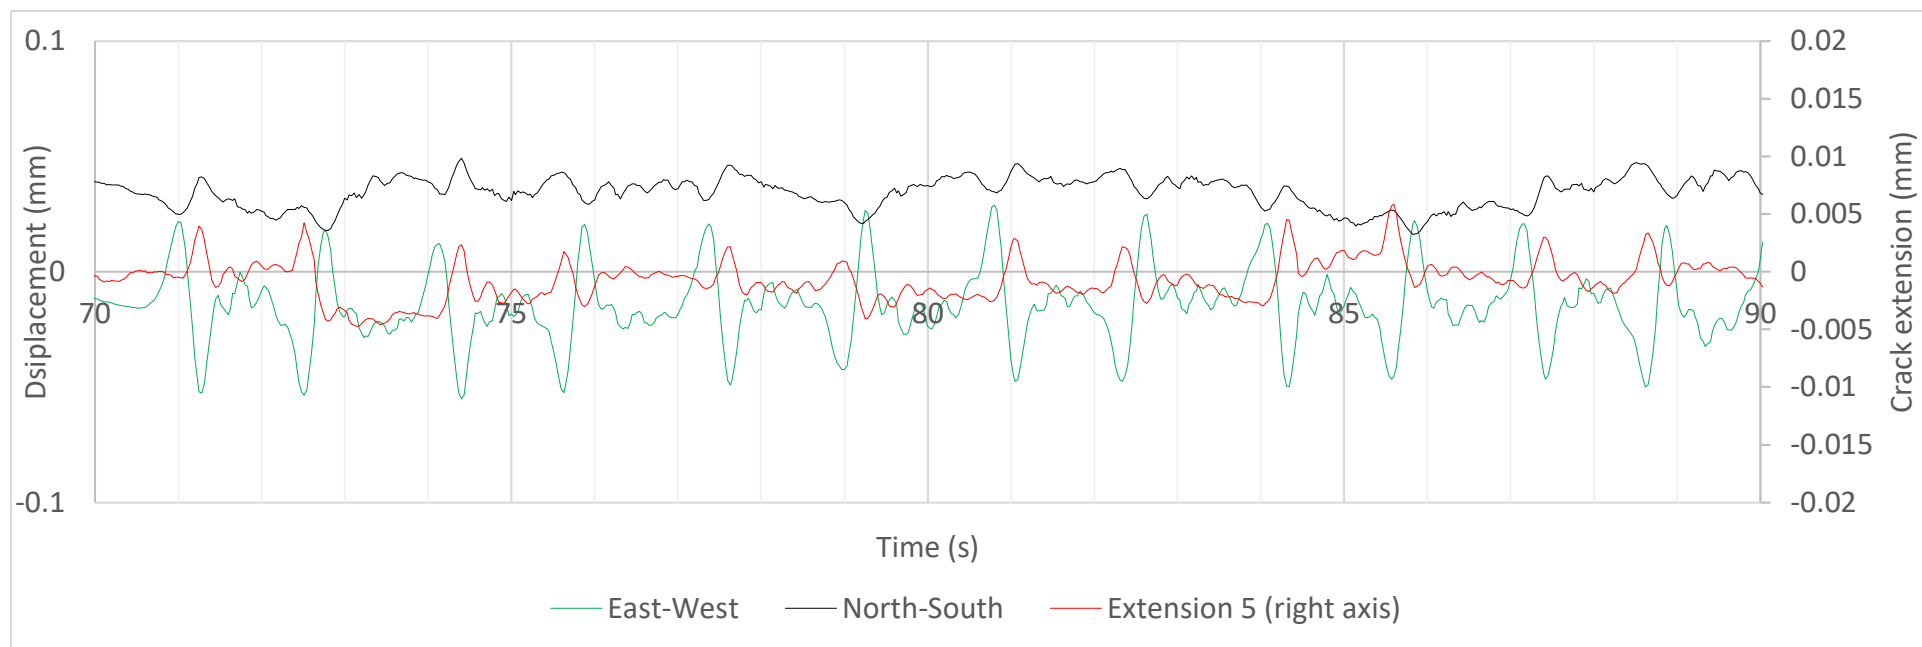
Figure 10. E-W and N-S movements of the arch, and extension of the crack, during the ringing of bell 7.

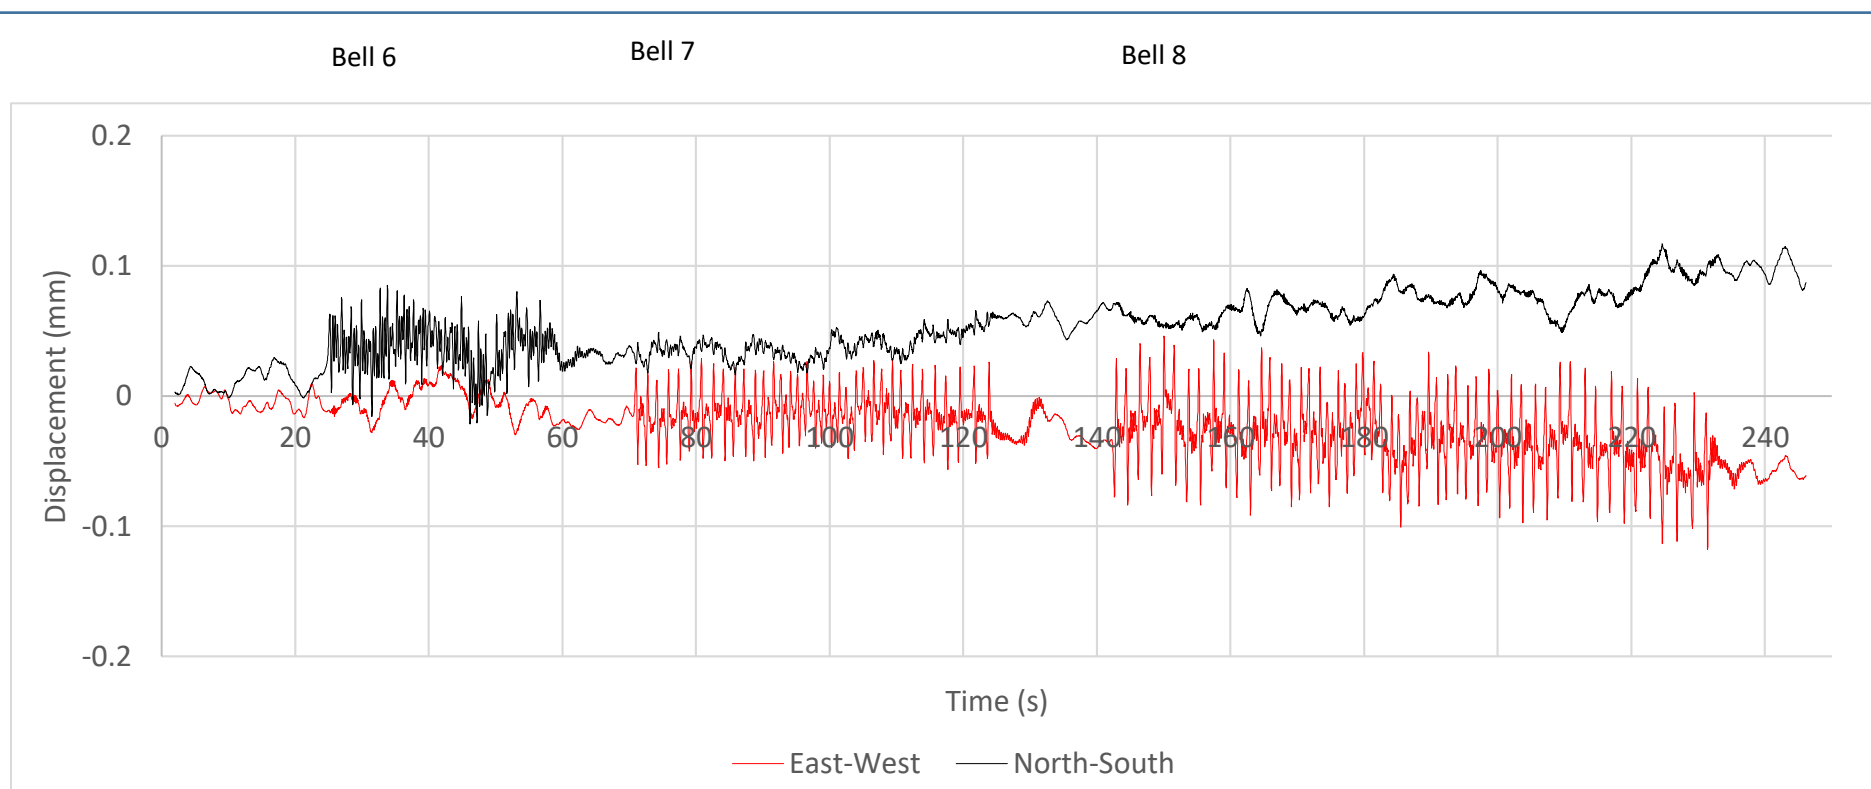
Figure 11. N-S and E-W movements of the top of the arch.

The major concern of this paper, however, is the overall pattern of movement, and the pursuit of an explanation for the behaviour experienced by the ringers. The N-S and E-W movement for the full sequence of observations is shown in Figure 11. The bells were rung in the sequence 6, 7, 8; the main movements correspond to the directions of swing. Both E-W and N-S show a drift in the readings, which is most likely to be due to a slow movement of the camera, probably due to expansion of the tripod legs as they had been outside prior to these observations – as little as a degree of temperature change could produce the movements observed. However, there are significant N-S movements when bells 7 and 8 are rung, and substantial E-W movements when bell 6 is rung. The latter may be due to the stiffening presence of the stair tower in the NE corner, so that there is some plan rotation about this corner as bell 6 is on the western side of the belfry, and so exerts a moment.

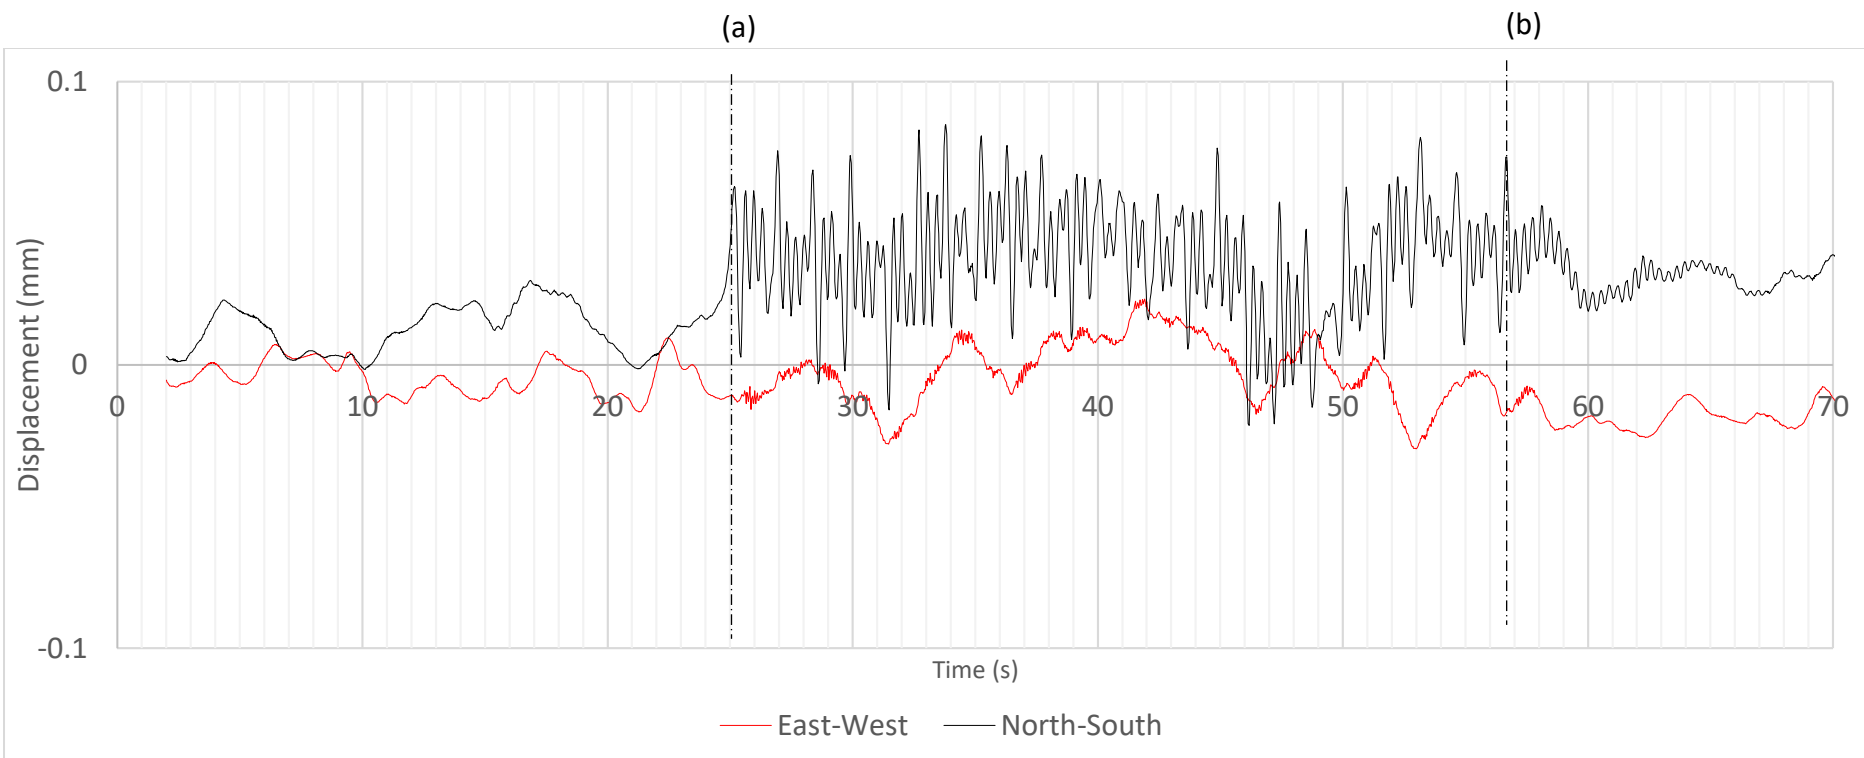
Figure 12. Observations of the movement of the top of the arch, including the ringing of bell 6.

Figure 12 shows the response to the ringing of bell 6 in more detail. The bell started ringing at point (a). The high frequency bending response of the tower is seen clearly, continuing for over ten seconds after the bell stopped ringing at point (b), showing very little damping at these very small amplitudes of movement. A similar pattern of motion after the bell was stopped is seen in Figure 13 for bell 7. In both cases the lower frequency rocking response of the tower is seen most clearly after the bells stopped, with a period of about 6s. This is within the range of rocking frequencies that have been predicted. The pattern of motion throughout the ringing is complex, suggesting possible interferences between different modes of oscillation. It appears that the damping for these oscillations is no stronger than that for the bending - the amplitude of the oscillations seen is also small. It is possible that the movement detected before the start of the recording was produced by the immediately preceding ringing. The pattern of the longer wavelength response is not at all clear, and if anything is more sawtooth than sinusoidal. It is definitely complex and uneven, which may relate to the 'lurching' reported by the ringers.

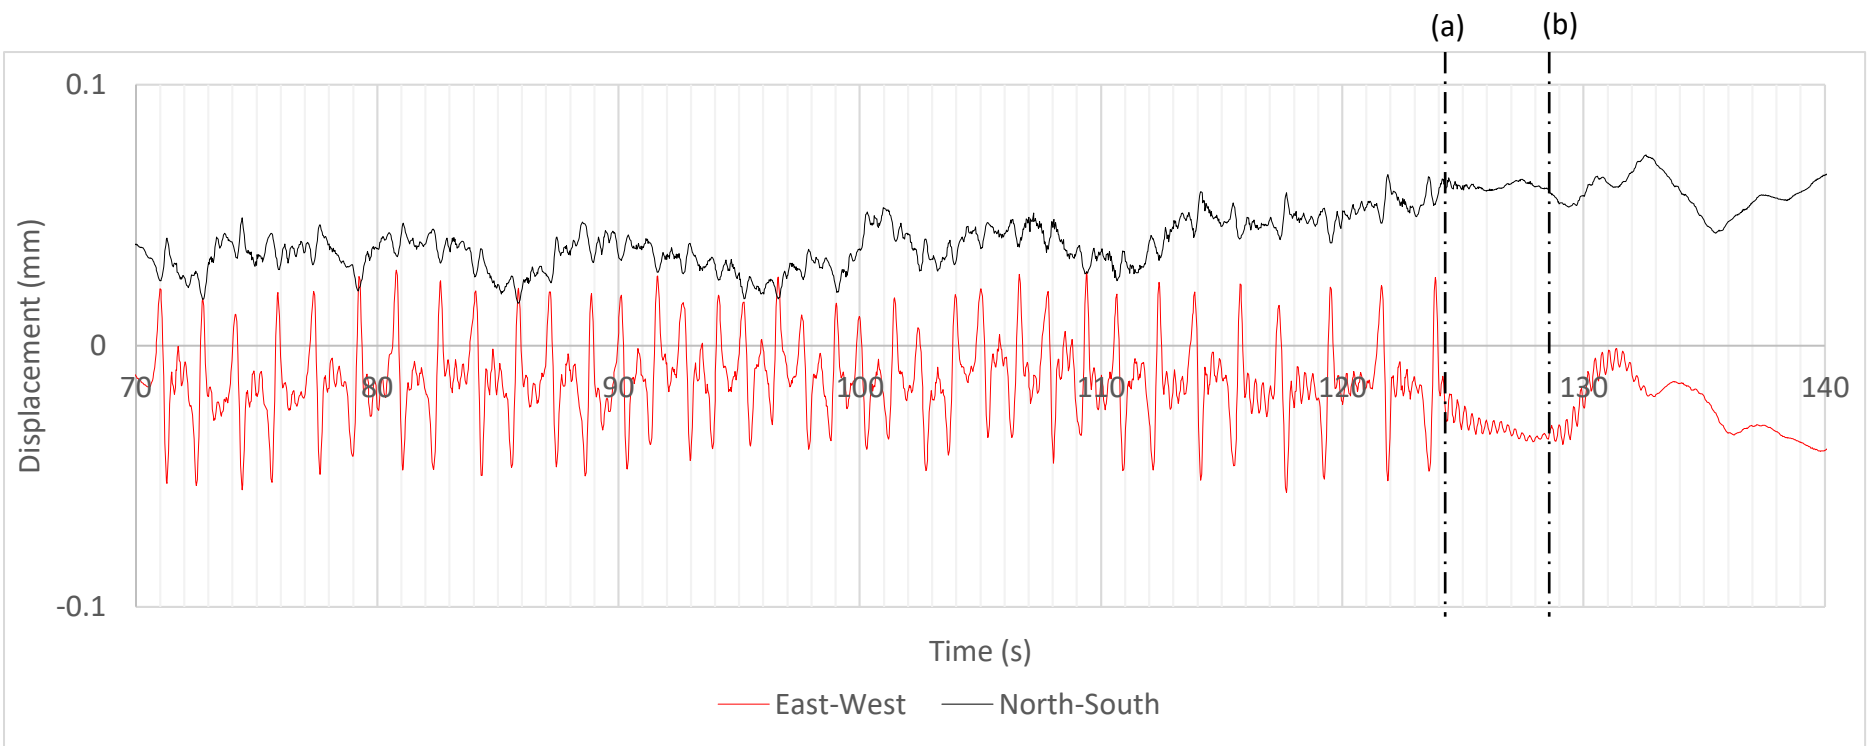
Figure 13. Observations during and immediately after the ringing of bell 7.

There appears to be interference between the rocking and bending responses. This is seen in Figure 13. The bell is stopped at point (a), after which the oscillations reduce in magnitude, the amplitude halving over about eight cycles. At point (b), the amplitude increases again, as a significant movement occurs at the lower frequency.
